RARITAN RIVER BASIN  
ROCKY BROOK, MERCER COUNTY  
NEW JERSEY

# ETRA LAKE DAM

## NJ 00298

### PHASE 1 INSPECTION REPORT NATIONAL DAM SAFETY PROGRAM

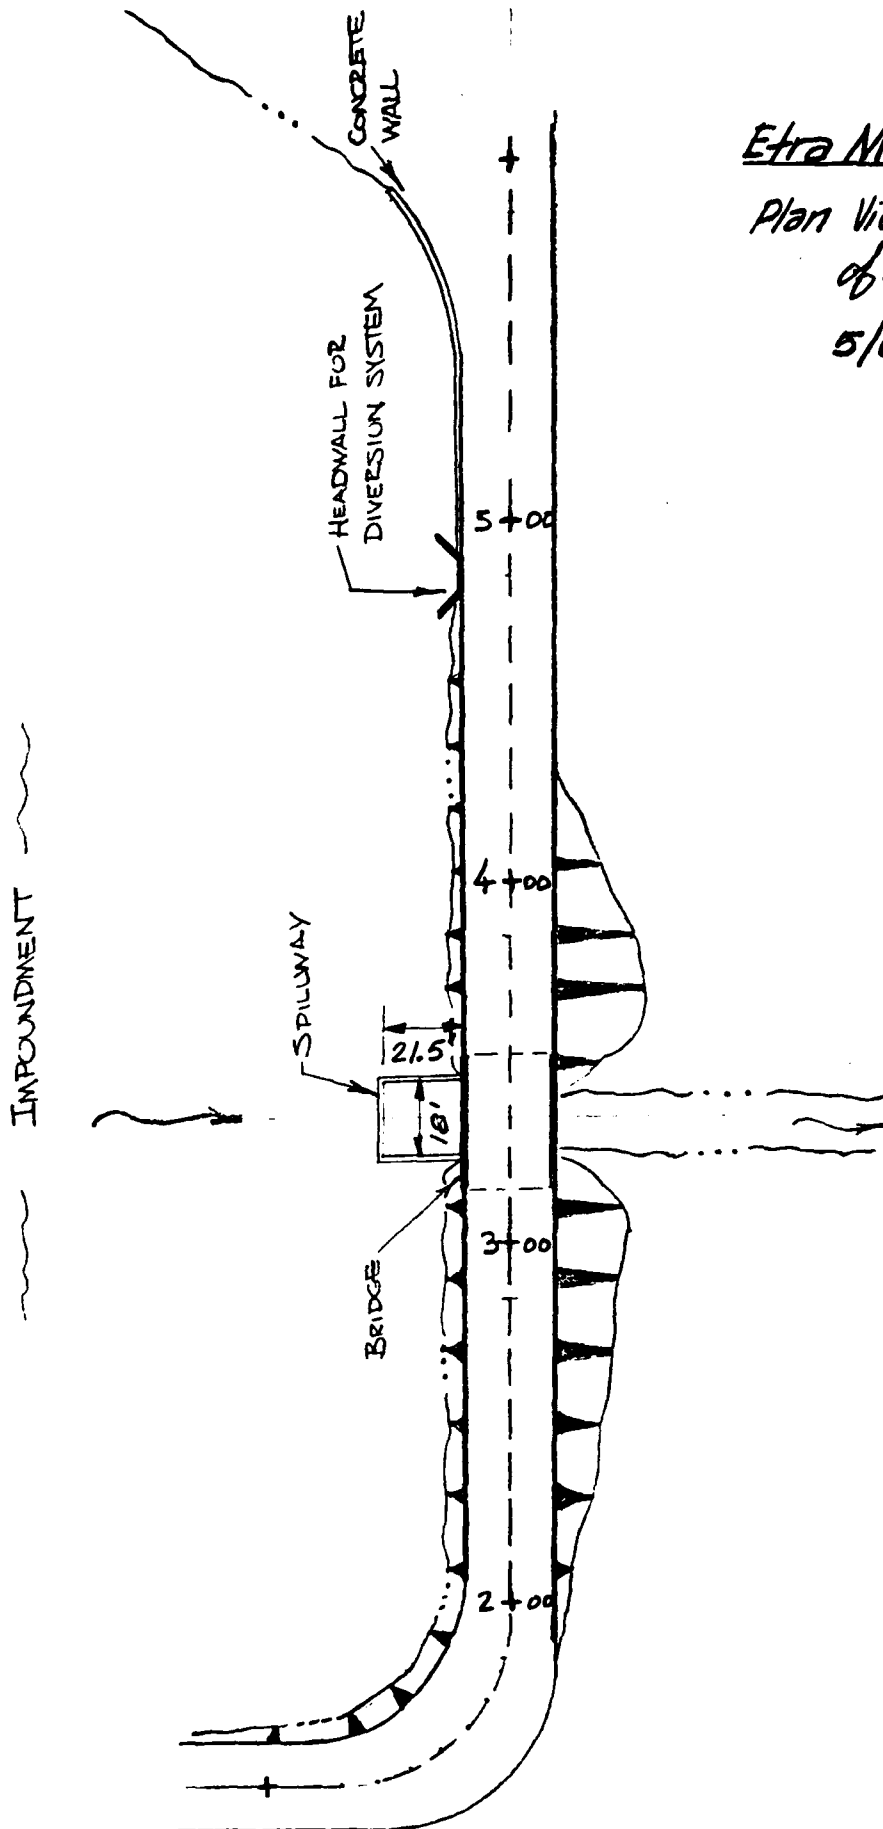
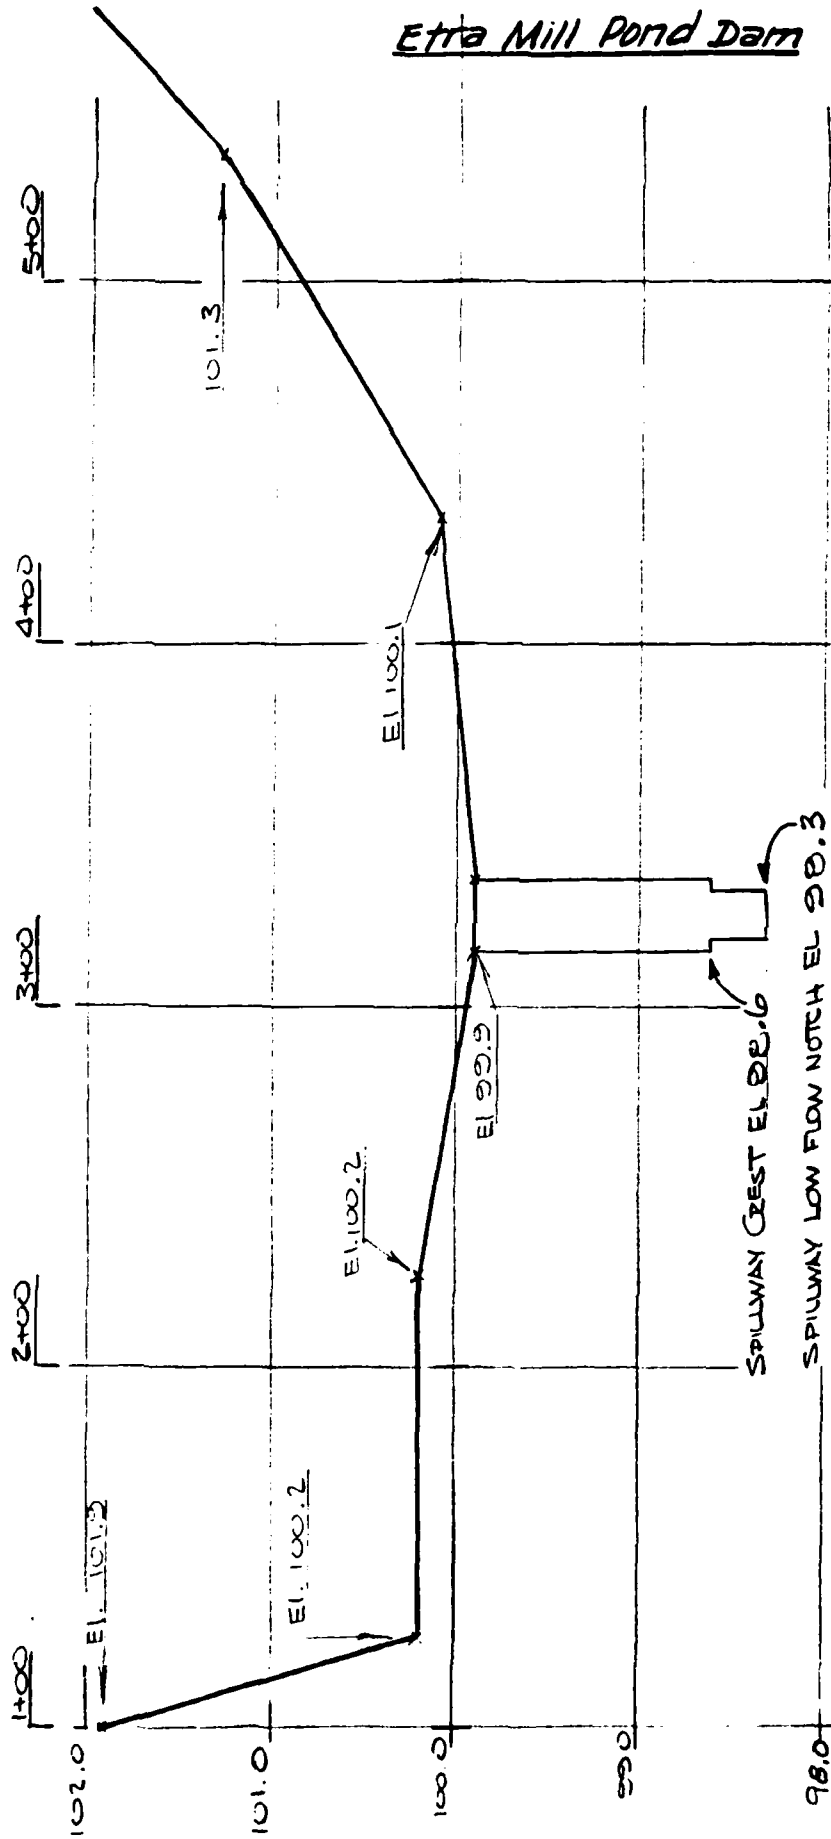
SURVEY-VERTICAL CREST ALIGNMENT  
MAY 6, 1981

b. Dam. The vertical and horizontal alignment of the dam appears to be fair. No significant settlement or slope misalignment was noted. A survey of the vertical alignment of the top of the dam was made by the inspection team. The maximum variation in vertical alignment is about 1.7 feet. A sketch of the survey results is included in Appendix E, Sheet 5.
